Operation **TEAPOT**

NEVADA TEST SITE

Project 35.1

EFFECTS OF ATOMIC WEAPONS
ON ELECTRIC UTILITIES

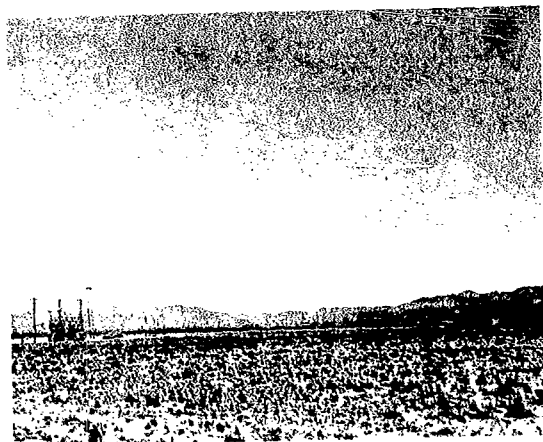
Fig. 3.1—Postshot view of the transmission line at the 4700-ft area.

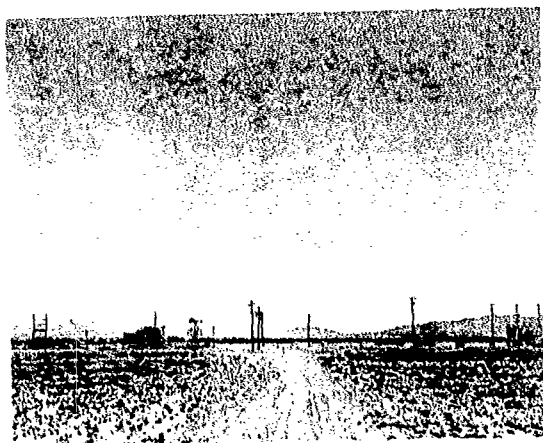
The substation had survived the blast with minor damage to its essential components. The metal cubicle itself, housing the meters and relays, was heavily damaged. However, this cubicle and its contents were not essential to the emergency operation of the system. The 4-kv regulators had been shifted on the concrete pad, resulting in separation of the electrical connections to the bus. The substation was in sufficiently sound condition to permit reenergizing on a nonautomatic basis.

Fig. 3.2—Postshot view of the substation at the 4700-ft line.

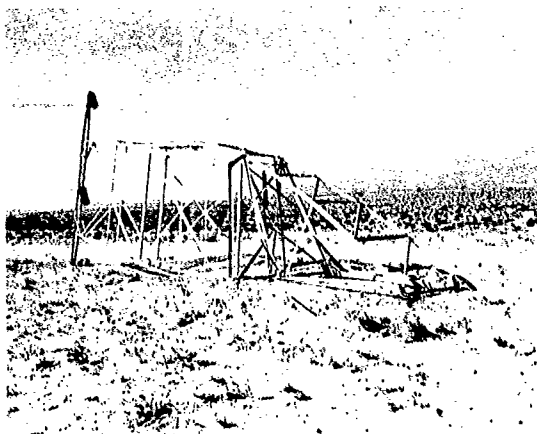
The only damage was to the suspension tower, which was blown over in a direction transverse to the transmission line (Fig. 3.4). The leg angles bent at the splice plates, which fastened them to the anchor stubs. The two leg members on the side of the tower away from the shot broke about 8 ft above the ground at a point where there were two 1/2-in. holes side by side on the 3-in. angle member. One insulator string was broken due to impact with the ground. The line conductors, splices, and hardware were undamaged.

Fig. 3.4—Structural failure of the suspension tower at the 4700-ft line.

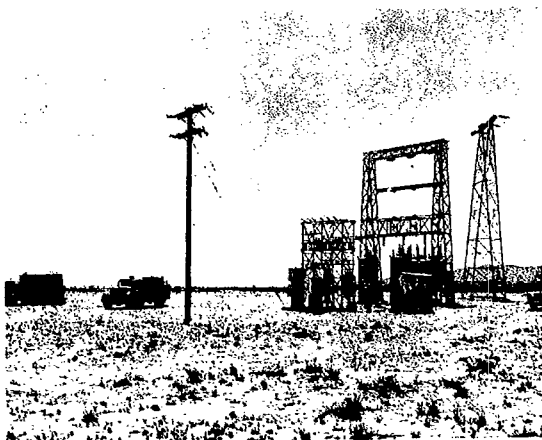
The steel dead-end structure supporting the 69-kv insulators, disconnects, and buses received minor structural damage (Fig. 3.5) in that two leg angles were slightly buckled at a point 3 ft above the foundation where several unused bolt holes were located.

Fig. 3.5—Postshot view of the substation at the 4700-ft line.

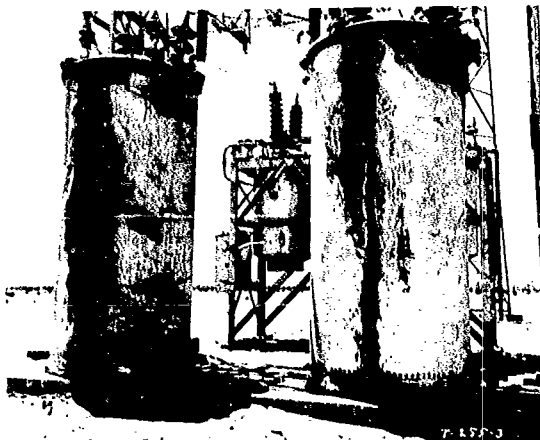
The two 1500-kva 69/11-kv transformers were undamaged and were not moved on the foundation pad. They later withstood a 30-kv a-c high-potential test to ground. The turn ratio between windings tested satisfactorily; and when meggered they gave the same values as was found in the pre-shot tests. The paint on the side of the case facing the blast was slightly blistered (Fig. 3.6). Neither the temperature nor the oil-level gauges were damaged.

Fig. 3.6—Thermal effect on the power transformer at the 4700-ft line.

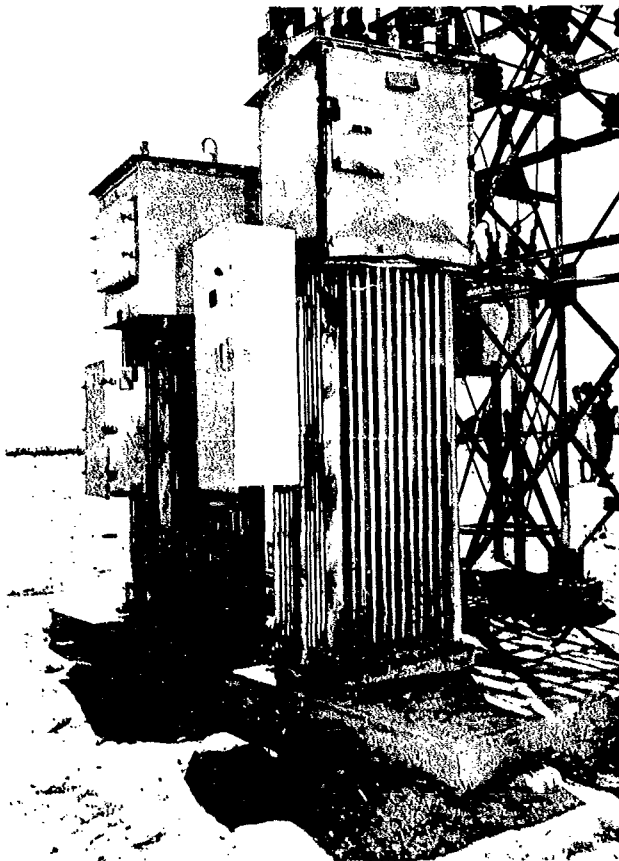
The two 4-kv 200-amp induction regulators were shifted on the foundation pad sufficiently to break electrical connections to the bus. In addition, the square flat-surfaced housing at the top of one regulator was dished on all four faces (Fig. 3.7). The flat-faced temperature-gauge glass was broken. The cylindrical oil-level gauge was not broken.

The regulators were tested and found to be electrically operative, but the raise and lower mechanism on one regulator was temporarily jammed. After approximately four operations of the raise and lower contactor, the mechanism was moving freely and was operating efficiently.

Fig. 3.7—Displacement of induction regulator and thermal effect on it at 4700 ft from GZ.

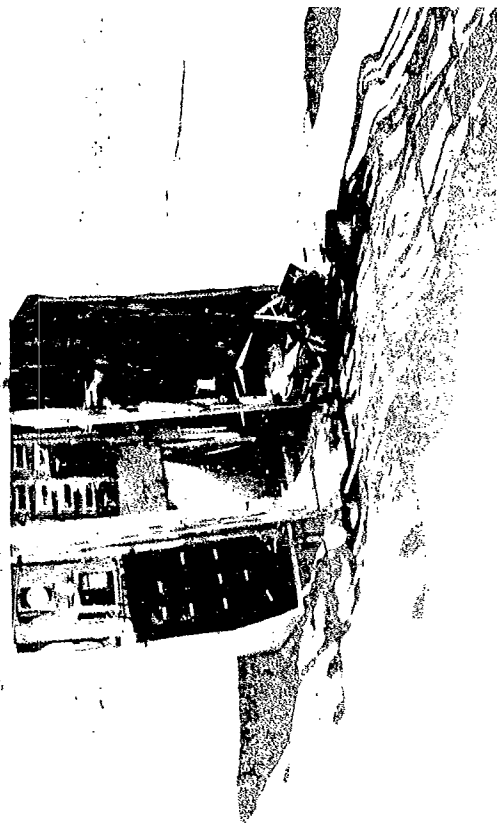
The three-compartment metal cubicle that housed meters, batteries, and instruments was severely damaged. The foundation pad to which this structure was bolted was noticeably tilted. See Fig. 3.8.

The battery cells were completely destroyed. All the glass cells were broken, acid was spilled over the ground, and most plates (both positive and negative) were damaged beyond repair.

The relays, instruments, and meters were tested identically to preshot tests and were found to be undamaged except for a broken cover glass on the recording wattmeter.

Fig. 3.8.—Damage to the relay cubicle at 4.00 ft from GZ.

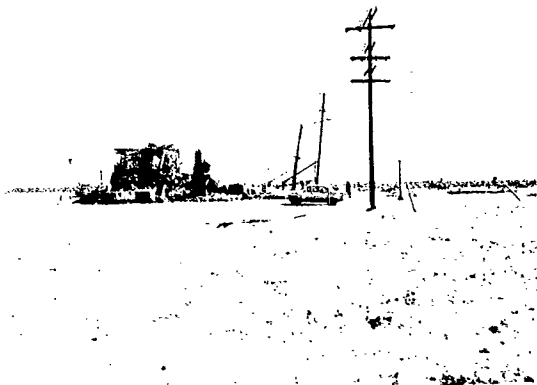
The distribution system sustained light to moderate damage. Of the poles in 14 positions, 5 were not damaged, 3 were very slightly damaged (to the extent of broken insulator pins on the 4-kv circuit only), 2 were extensively damaged, and 4 were down. No 11-kv metal insulator pins failed; and, except for down poles, the 11-kv circuit could have been reenergized. Slight scorching occurred to poles and crossarms. See Figs. 3.9 and 3.10.

Fig. 3.9—Failure of the distribution circuit at the rear of the 4700-ft property line.

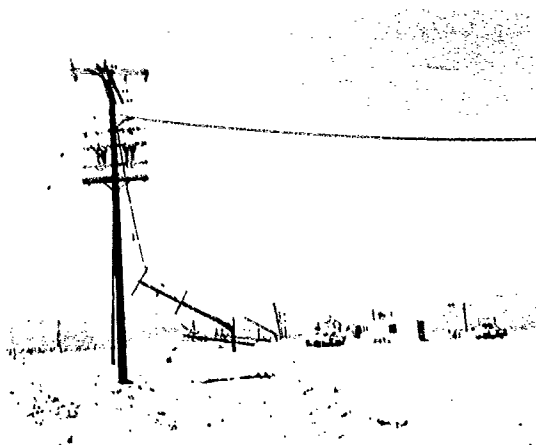
Fig. 3.10—Damage to pole 12 at 4700 ft from GZ.

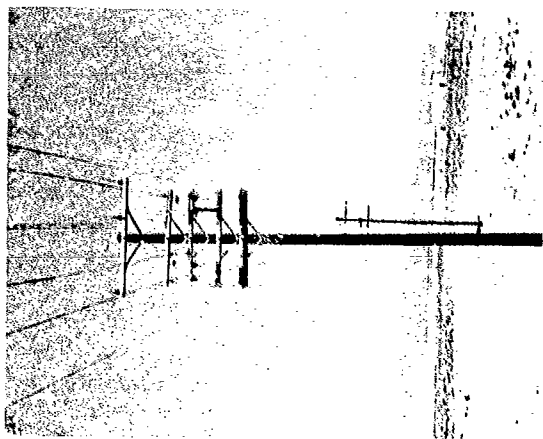
Pole 1 sustained one missing 11-kv insulator, but the pin was still in place in the crossarm. Poles 2 and 3 were undamaged. Pole 4 had two 4-kv wood insulator pins sheared and one pulled out of crossarm. The two 10-kva transformers were in place and undamaged although the crossarm on which they were hung was badly cracked. See Fig. 3.11. Pole 5 was undamaged. On pole 6 the 11-kv circuit was intact, but the 4-kv and secondary crossarms were splintered, apparently by house missiles. The 15-kva transformer was knocked to the ground at a distance of 36 ft from the pole. See Fig. 3.12. On poles 7A and 7B, the 11-kv circuit was intact, but four of the 4-kv wood insulator pins sheared, and two others pulled out. The crossarms were undamaged. The poles were displaced 4 in. at ground level and were leaning away from the blast due to the weight of adjacent down poles. See Figs. 3.13 and 3.14. The three 50-kva platform-supported transformers were blown to the ground, apparently by blast and missiles from the houses. See Fig. 3.15. The crossarms were undamaged. Pole 8 broke about 8 ft above ground level. The top portion leaned 60° from the vertical. One wood pin sheared on a 4-kv crossarm in the 4-kv circuit. The pothead was undamaged; the riser pipe bent, but the cable was undamaged. Secondaries between poles 7b and 8 snapped at the insulators on pole 8. See Fig. 3.16. Pole 9 broke at ground level, but the 11-kv circuit was intact. No damage was noted to the crossarms, capacitors, or insulators. The aerial cable was unbroken from pole 9 to pole 14. See Fig. 3.17. Pole 10 broke 1 ft below ground level. A 15-kva transformer was knocked to the ground and broken. The top of pole was split. The 11-kv crossarm was not broken but was separated from the pole. One 11-kv insulator was broken. The crossarm supporting the aerial cable was separated from the pole but was held on by the braces. One 11-kv conductor (#2/0 ACSR) was frayed and cut in half by the radio-tower guy wire on which it fell. See Figs. 3.18 and 3.19. Pole 11 was broken 8 ft above the ground. One 11-kv insulator was broken. The riser pipe was bent, but the pothead and the aerial cable were not damaged. See Fig. 3.20. Pole 12 was undamaged; the two 10-kva transformers remained in place and were not damaged. The pole bent about 5° in the direction of the downed poles. Pole 13 had one 11-kv insulator missing. The mast arm of the luminaire was deflected about 10°. The globes, which were elliptically shaped, were not broken. Pole 14 was not damaged. The mast arm of the luminaire was deflected about 10°, but the elliptical globes were not broken.

Fig. 3.11—Damage to pole 4 at the 4700-ft line.

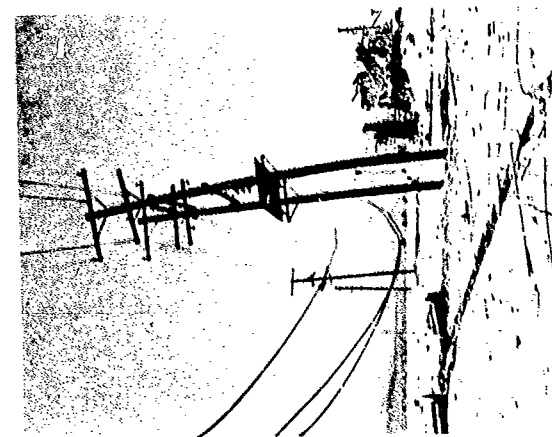
Fig. 3.13—Damage to poles T.A and T.B at the 4700-ft line.

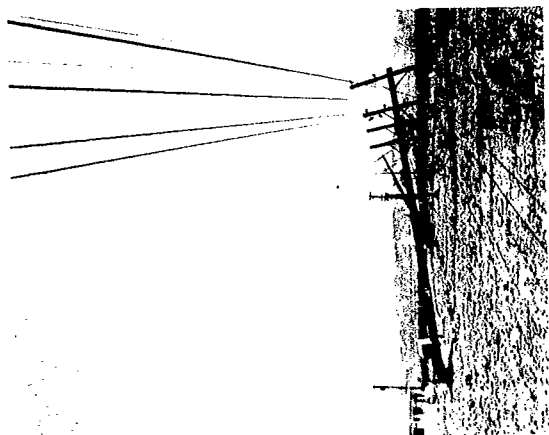
Fig. 3.14—Damage to distribution poles at the 4700-ft line.

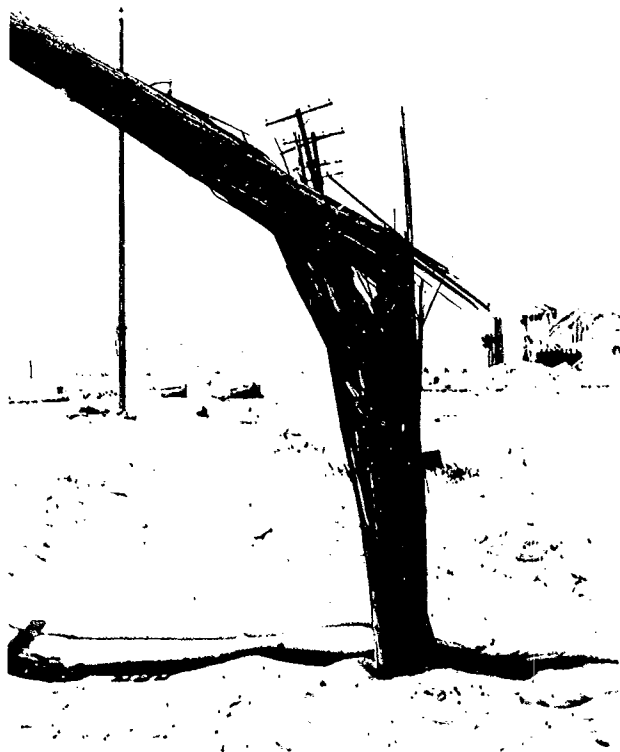
Fig. 3.10—Damage to pole 8 at the 4700-ft line.

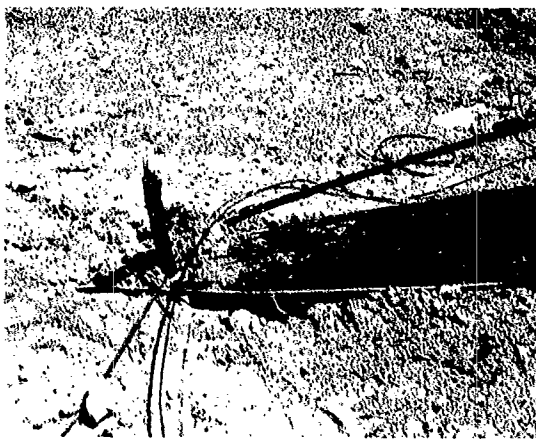
Fig. 3.18—Damage to pole 10 at the 4700-ft line.

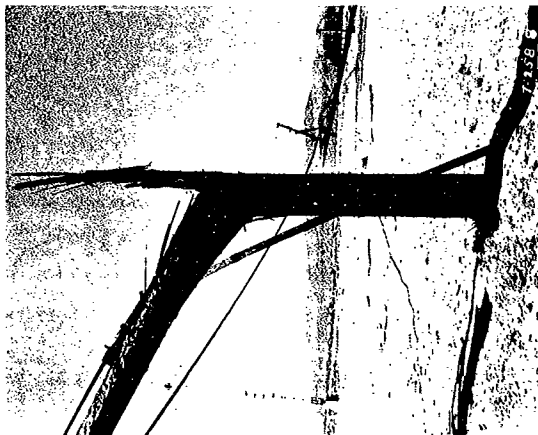
Fig. 3.20—Damage to pole 11 at the 4700-ft line.

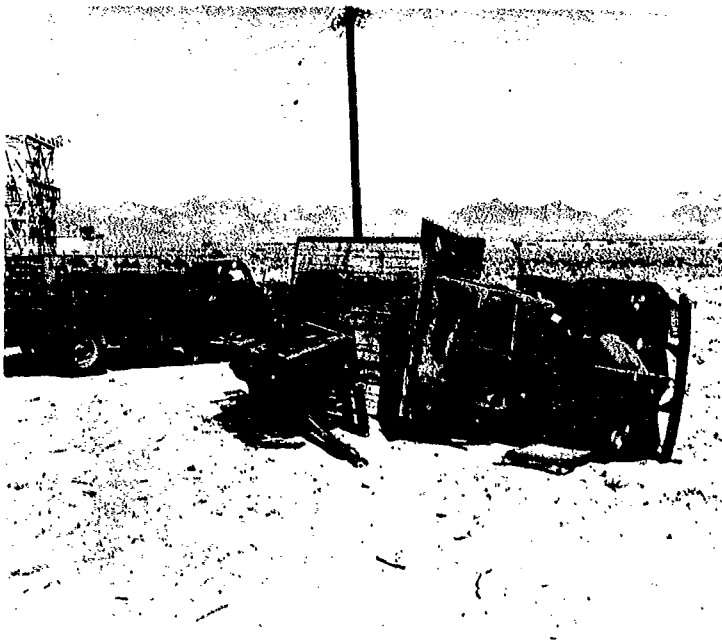
The truck that was equipped with an earthboring machine (also exposed in Project 36.2) tipped over, sliding the boring machine to the ground (Fig. 3.21).

Fig. 3.21 — Damage to service vehicles at the 4700-ft line.
